Lesson learned so far - Fukushima-I Nuclear Power Plants Accidents

**Presented by: Muhammad Ayub
Project Director**

Pakistan Nuclear Regulatory Authority

**INTERNATIONAL SEMINAR ON NUCLEAR SAFETY AND
SECURITY CHALLENGES OF THE 21ST CENTURY**

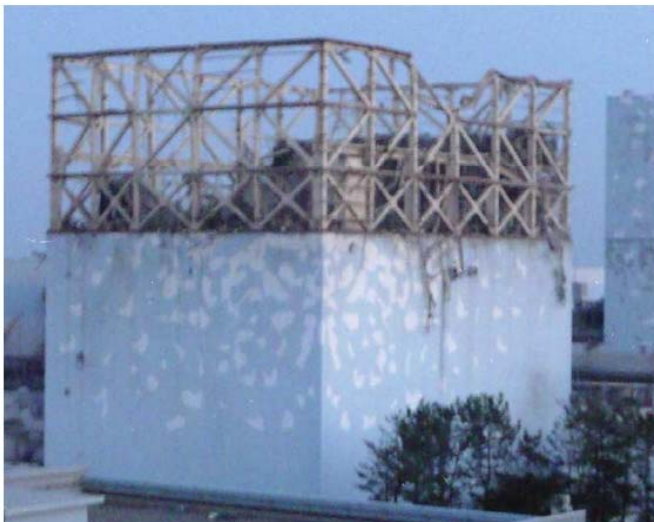
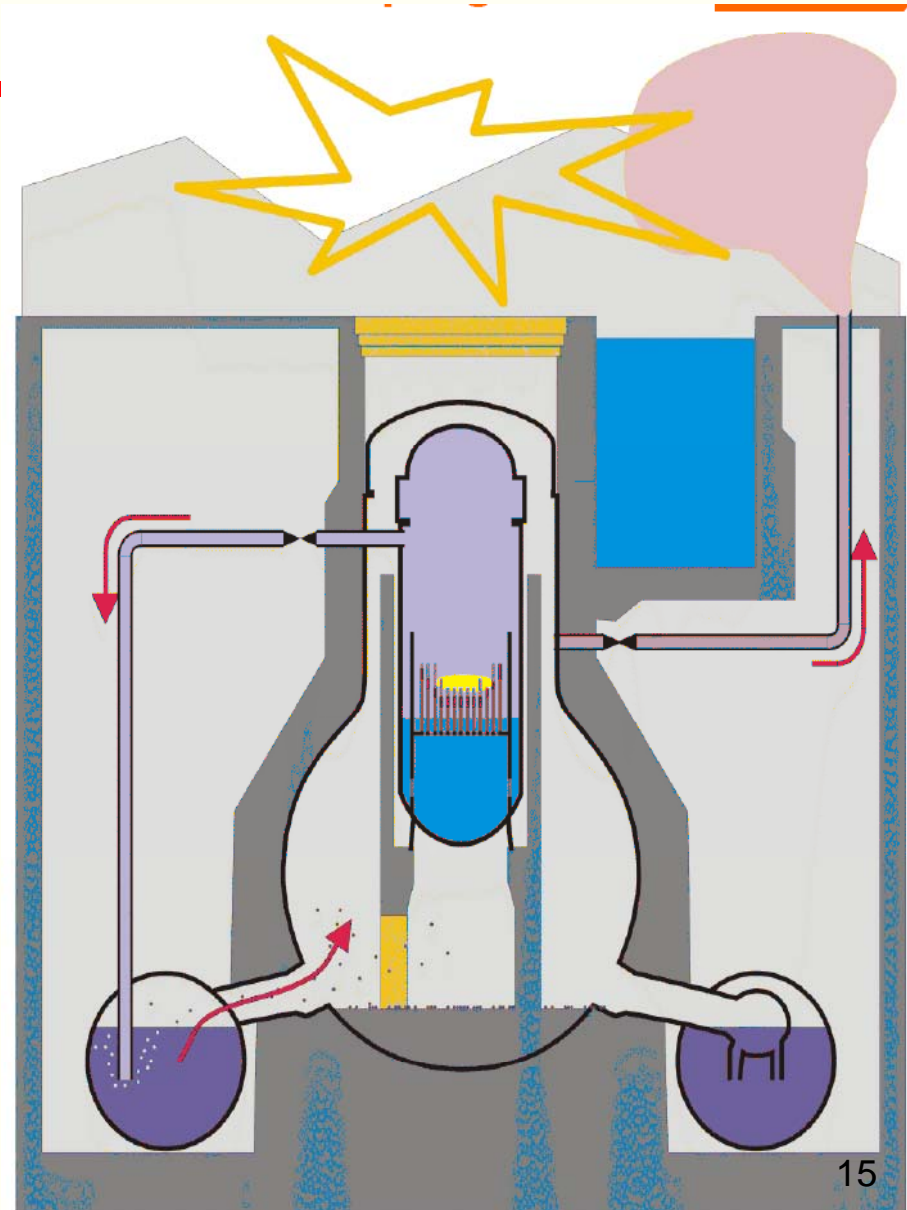
Unit 1 und 3

- ❖ Hydrogen burn inside the reactor building. Destruction of the steel-frame roof
- ❖ Reinforced concrete reactor building seems undamaged.

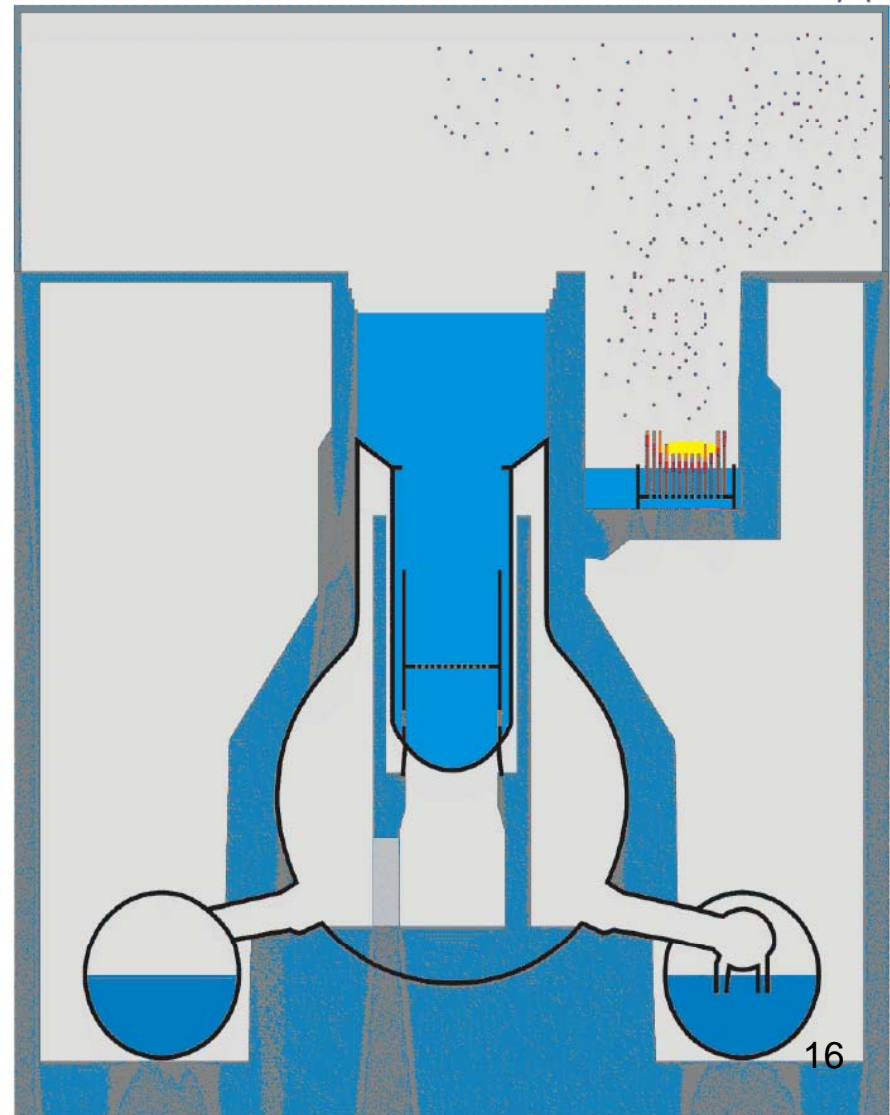
Fukushima Unit # 4

- ❖ Due to maintenance in Unit 4 entire core stored in Fuel pool
- ❖ Spend fuel stored in Pool on Reactor service floor
- ❖ Leakage of the pools due to Earthquake? Or loss of cooling. Dry-out of the pools
- ❖ Consequences - Core uncover – Oxidation of cladding – Generation of Hydrogen
