Lesson learned so far - Fukushima-I Nuclear Power Plants Accidents

**Presented by: Muhammad Ayub
Project Director**

Pakistan Nuclear Regulatory Authority

**INTERNATIONAL SEMINAR ON NUCLEAR SAFETY AND
SECURITY CHALLENGES OF THE 21ST CENTURY**

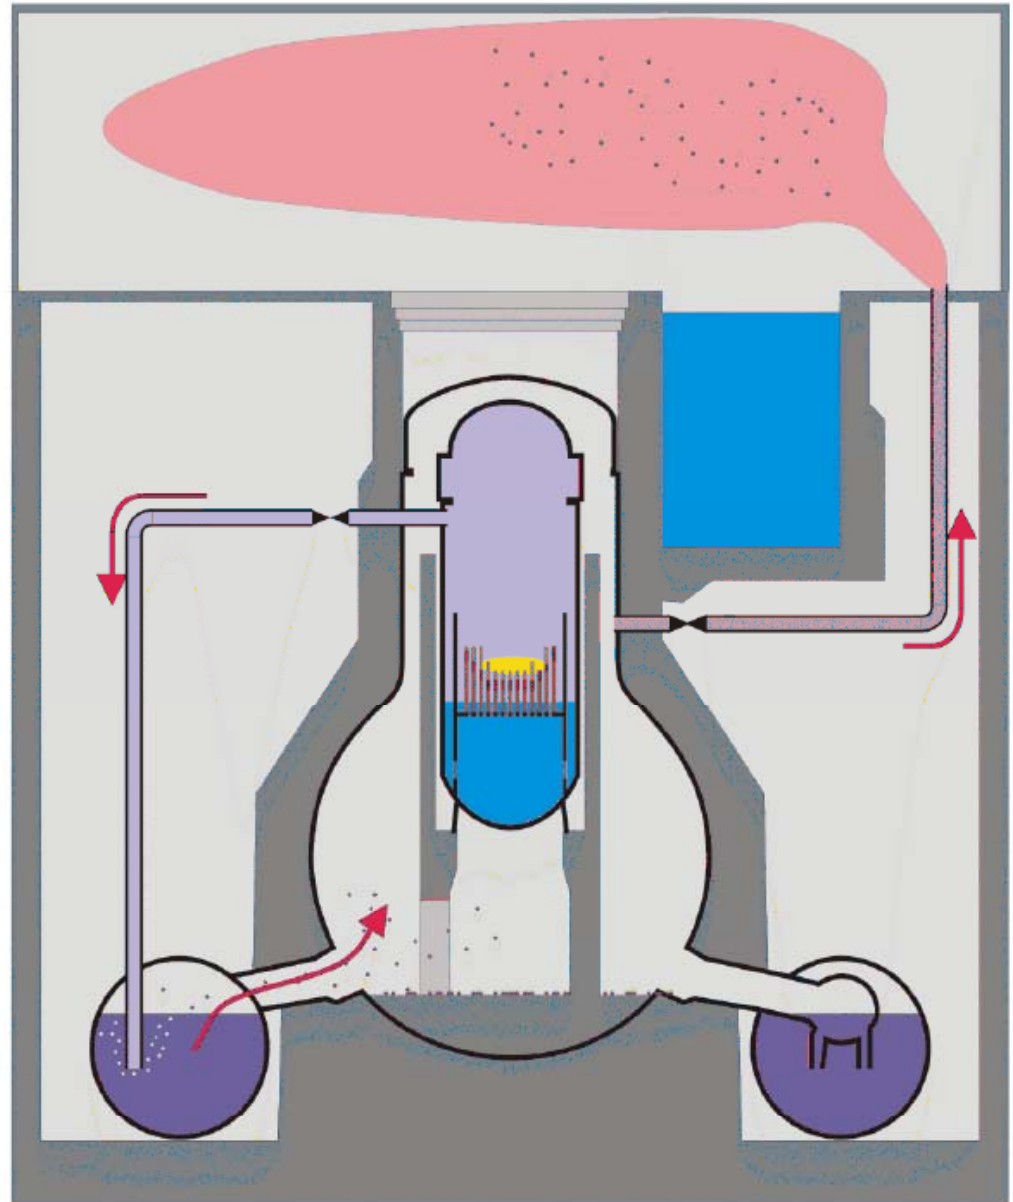
Unit 1 und 3

- ❖ Hydrogen burn inside the reactor building. Destruction of the steel-frame roof
- ❖ Reinforced concrete reactor building seems undamaged.
